James A. FitzPatrick
Nuclear Power Plant
268 Lake Road
P.O. Box 41
Lycoming, New York 13093
315-342-3840

November 15, 1999
JAFP-99-0304

Subject: **Docket No. 50-333**
LICENSEE EVENT REPORT: LER-99-010 (DER-99-02065)

**Main Turbine Trip and Reactor Scram Due to Degraded Cable in Main
Generator Anti-Motoring Circuit**

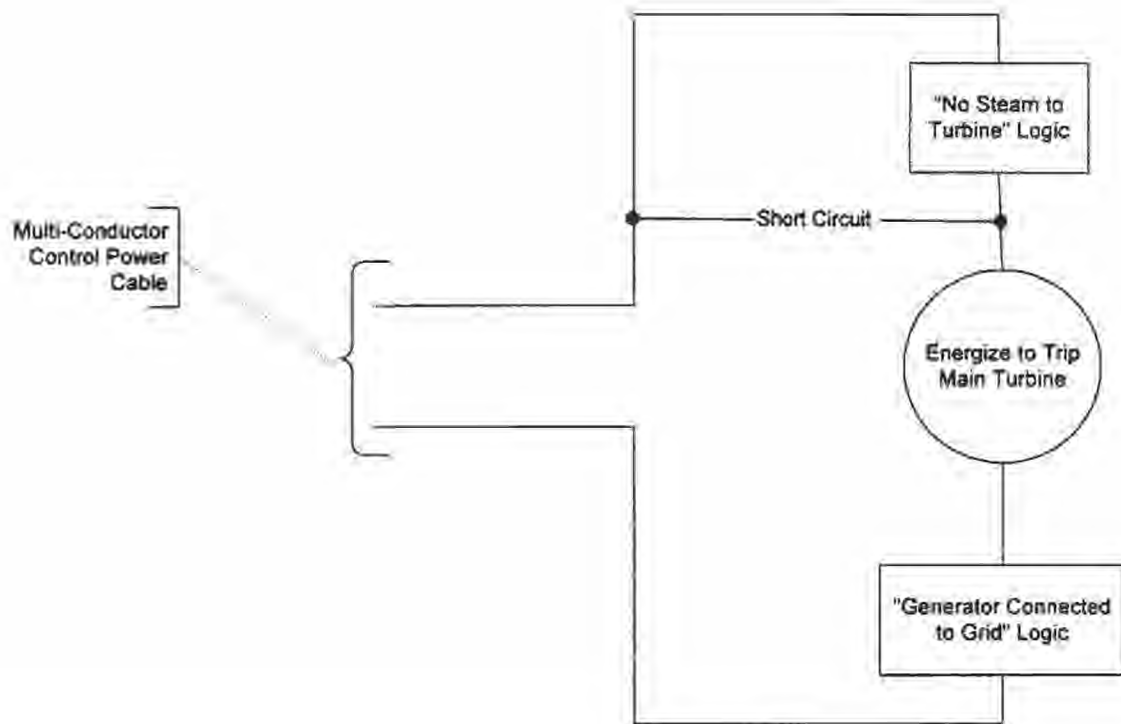
Figure 1

On October 14, 1999 at 17:44, an automatic Main Turbine [TA] trip occurred due to a short circuit between conductors in a control cable in the Main Generator [TB] anti-motoring protective relay circuit. (Figure 1). A Reactor scram occurred as a consequence of the Main Turbine trip based on Turbine Control Valve Fast Closure signals.

The cause of this event was damaged insulation on a control power cable to the Main Generator anti-motoring circuit. The mechanism that caused the damaged insulation has not been identified (Cause Code X). Analysis to determine the cause of the insulation degradation is scheduled for the cycle 15 refuel outage (Fall 2000).

The extent of this condition is limited to this single cable. The insulation resistance of all the conductors in all of the cables run in this common conduit was checked using testing appropriate to the conductor's application (resistance checks or megger checks). These checks verified adequate insulation resistance for all conductors.

Main Generator Anti-Motoring Circuit Simplified Block Diagram

1. The Main Generator anti-motoring circuit was repaired. The repair used spare conductors in the control power cable with the degraded insulation. These spare conductors were verified to have adequate insulation integrity by meg-ohm testing prior to conducting the repair. (Complete)
2. The HPCI System piping was analyzed to determine if the overpressure condition had an adverse effect on the integrity of the pipe. This analysis concluded the piping was not adversely effected and remained operable. (Complete)
3. Perform analysis to determine the cause of the degraded cable. (Scheduled to be complete prior to restart from R014)
4. Replace the degraded cable with a new cable. (Scheduled to be complete prior to restart from R014)
